# *Tree damage caused by mobile phone base stations*

## *An observation guide*

*By Helmut Breunig*

*March 2017*

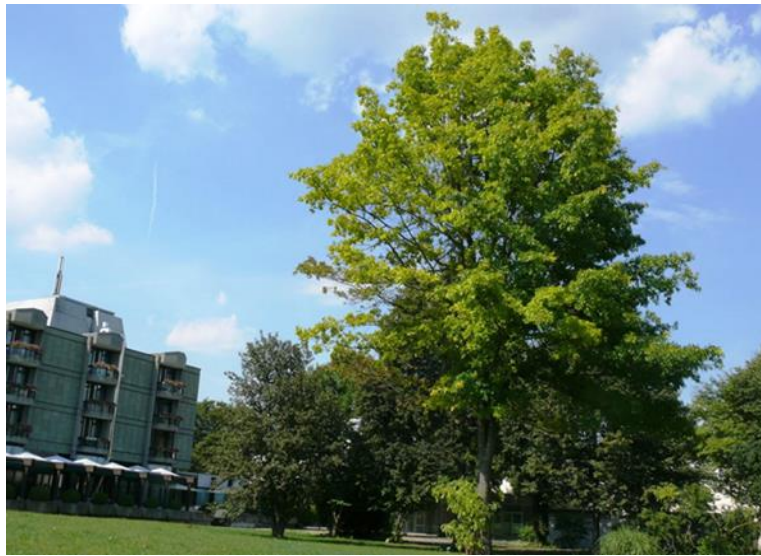
*Red oak tree,  
August 2013*

*At the location of the red oak tree shown here, none of the known stress factors are obvious. Still, the crown is damaged in a way that corresponds to the above-shown graph. The tree is in the line of sight of a nearby mobile phone base station.*

*The direction of the RF emission source and the location of the starting point of damage on the side of the tree facing the mobile phone base station coincide with each other.*

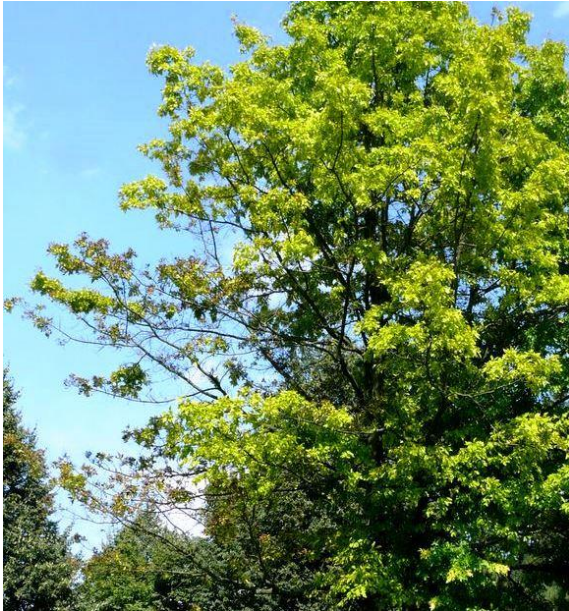
*Red oak tree, August 2013*

*Red oak tree, August 2015*

*Section of red oak tree, August 2013*

*Section of red oak tree, August 2015*

*The damage area spreads across the crown over the course of the coming years. At the individual branches, the sight is similar to drought damage. The spatial and temporal development of the damage area as a whole, however, is not typical for drought damage that occurs as a result of a lack of water at the roots.*

*The loss and discoloration of the leaves is most prominent where the tree faces the RF transmitter. The spread of the damage area follows a pattern independent of the branch architecture of the tree.*

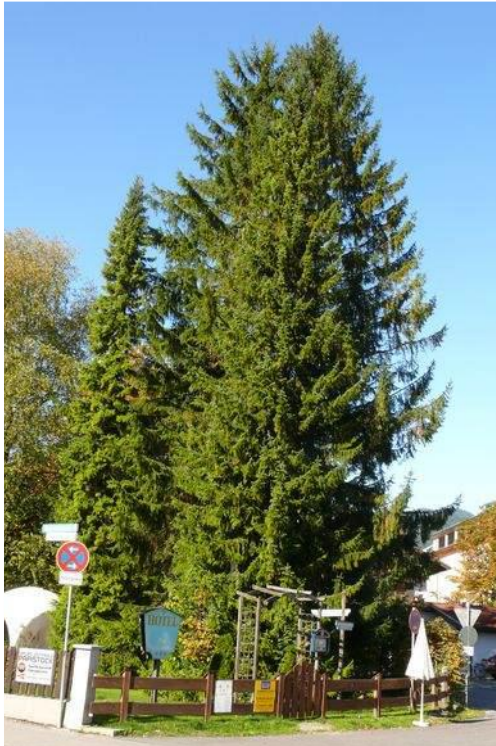
*Spruce, October 2010*

*Exposure from the right side,  
260 m (ca. 850 ft)*

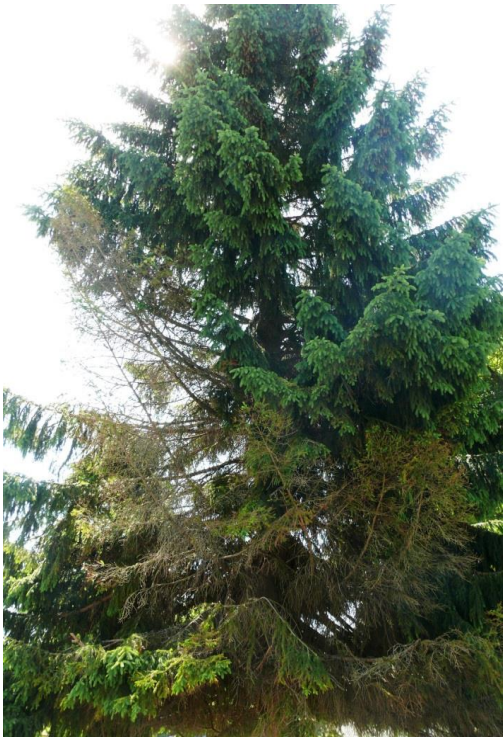
*Spruce, June 2003*

*Exposure from the left side,  
200 m (ca. 660 ft)*

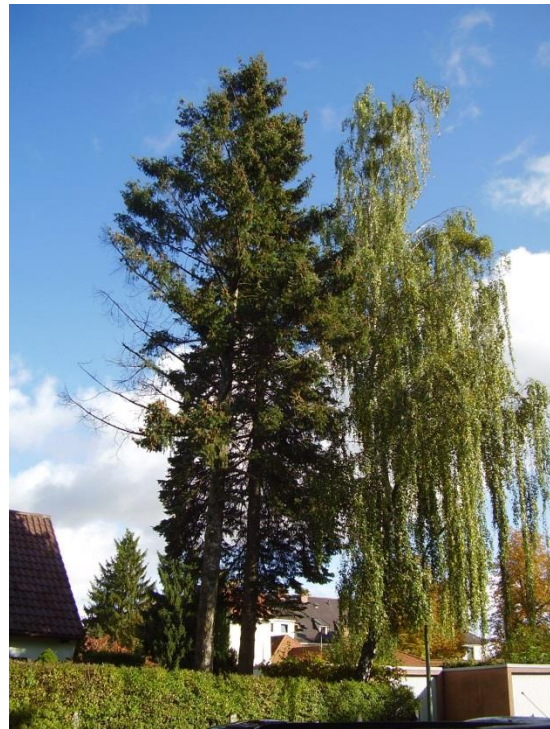
*Spruce, October 2008*

*Exposure from the left side,  
310 m (ca. 1000 ft)*

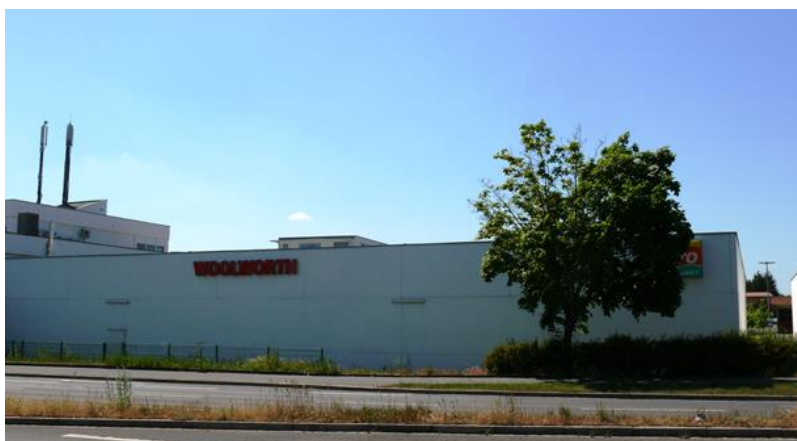
Norway maple tree,  
June 2015

The damage decreases on the side of the crown facing away from the RF transmitter (damage gradient), which can be explained by the attenuation effect of the foliage. Due to the absorption and scattering of the RF radiation along its path through the foliage, the power flux density of the RF radiation decreases (used measurement unit: microwatt per square meter =  $\mu\text{W}/\text{m}^2$ ). Comparison measurements between the side of the tree crown facing the RF transmitter and the side facing away from it confirm this.

Exposure from  
upper left ->

The agreement between the spatial orientation of the damage gradient and the gradient of the RF measurements suggests that the damage is associated with the RF radiation exposure from the RF transmitter.

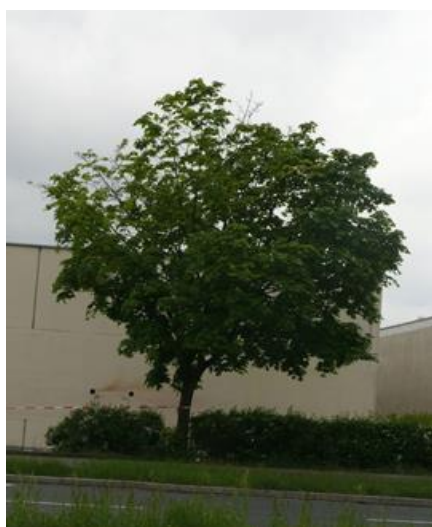
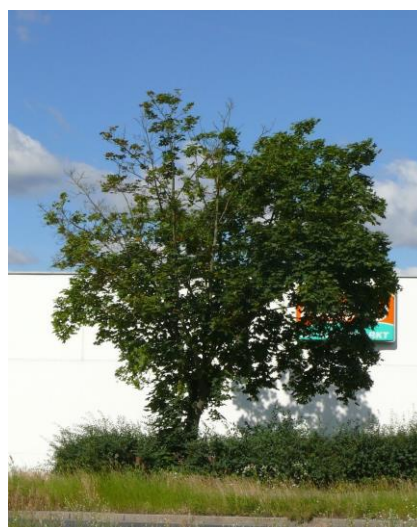
*The damage increases over the years and spreads from the direction of the RF transmitter across the crown. No regeneration can be seen. This is a sign of chronic exposure to a damaging factor. The RF exposure from the mobile phone base station within sight began between 2006 and 2008.*

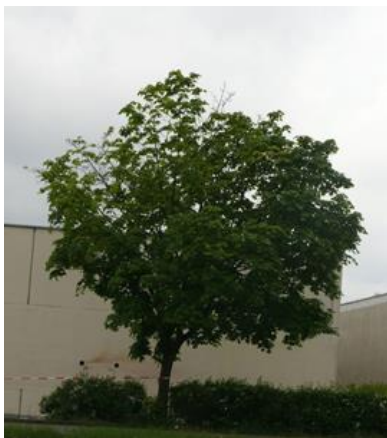
*May 2013*

*The tree is located at a strip of greenery, running in a north-south direction. To the east (foreground), the root area is sealed by a traffic area. The damage area points toward south where the RF transmitter is located. Despite the less than favorable climate conditions at this side, the crown on the north side has expanded.*

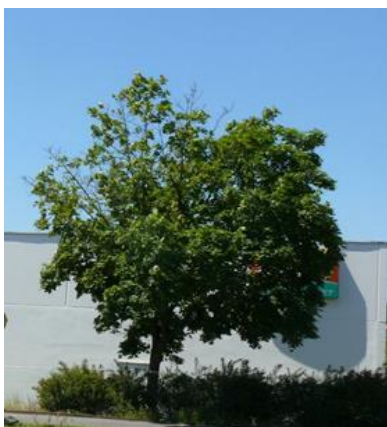
*June 2014*

*At the upper left – where the RF radiation hits the crown – the dieback at the edge is the most severe.*

*The annual increase in leaf loss most likely can be traced back to an impairment of the buds in the year before. The resulting decreased level of shoots for leaves and branches causes the closed crown to open at those points, whereby one quarter of the crown outline starts breaking up.*

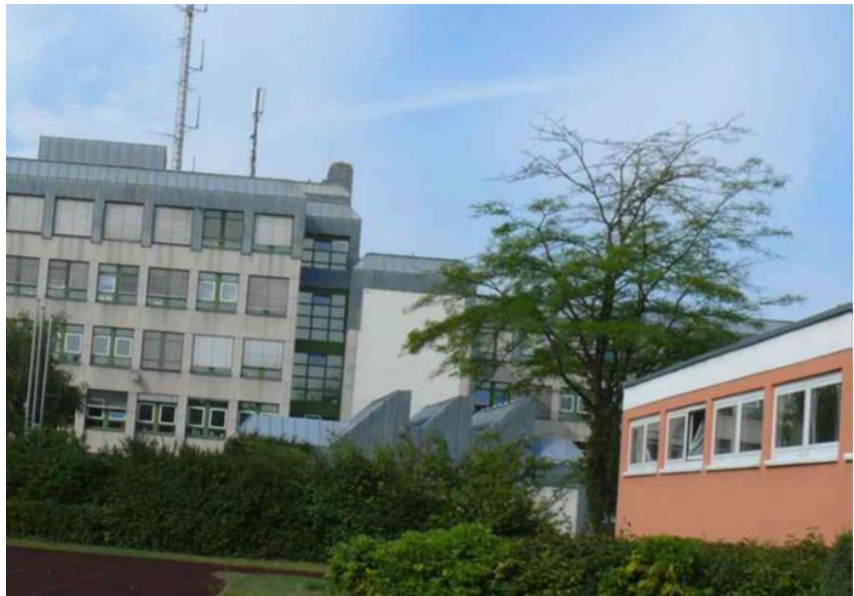
*If the RF radiation exposure comes from above, the damage is particularly prominent at the top of the tree.*

*Gleditsia tree  
September 2011*

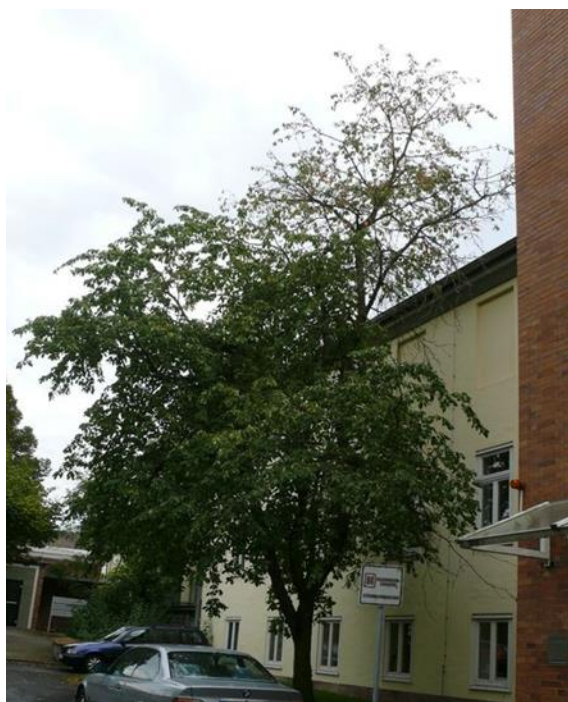
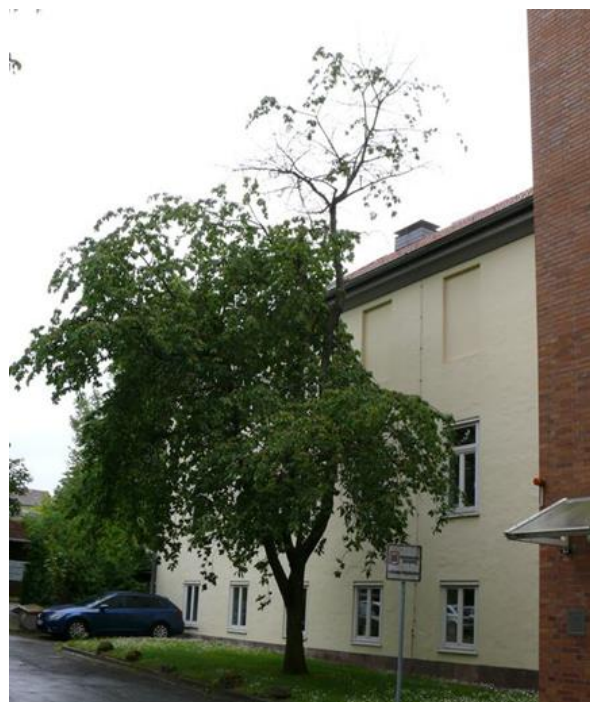
*Exposure from the right  
above the rooftop*

*Cherry tree, September 2012*

*Distance to multiple RF transmitters  
150-500 m (ca. 500-1600 ft)*

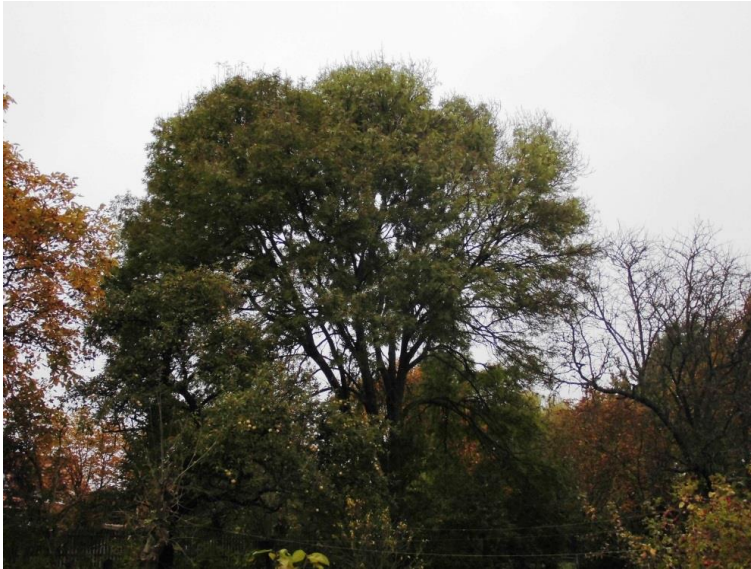
*Ash tree, October 2016*

*Ash trees naturally lose their leaves in fall without major discoloration. If the leaves of one tree start falling in different areas of the crown at different times, this can be the result of a one-sided RF exposure. This characteristic requires observing the tree over several years. Thus it would be possible to distinguish the damage from the acute effects of frost, which can be caused by cold air that blows in from the side.*

*<- Exposure from the right  
from RF transmitter at  
the same height,  
distance 500 m  
(ca. 1600 ft)*

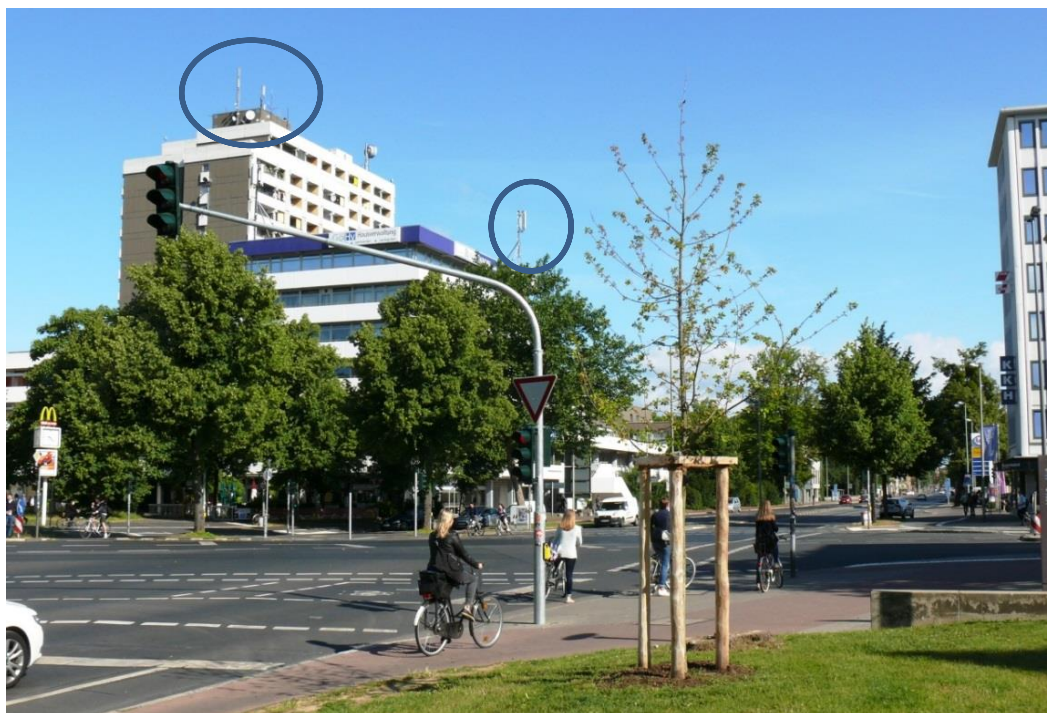
*Typical city view with trees in the vicinity of mobile phone sites  
July 2015*

*The linden trees to the left in the blind spot near the antennas (marked) don't seem to be adversely affected. Other trees in the background along the road and the newly planted tree in front of the building all are in the line of sight of the RF transmitters on the rooftop. Here we can recognize damage to the shape of the top of those trees and to the density of their foliage.*
