# *Tree damage caused by mobile phone base stations*

## *An observation guide*

*By Helmut Breunig*

*March 2017*

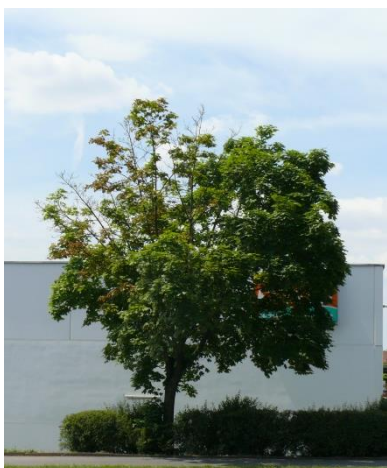
*June 2015*

*The annual increase in leaf loss most likely can be traced back to an impairment of the buds in the year before. The resulting decreased level of shoots for leaves and branches causes the closed crown to open at those points, whereby one quarter of the crown outline starts breaking up.*

*With increasing leaf dieback, the attenuation effect of the foliage decreases, starting at the edge of the crown.*

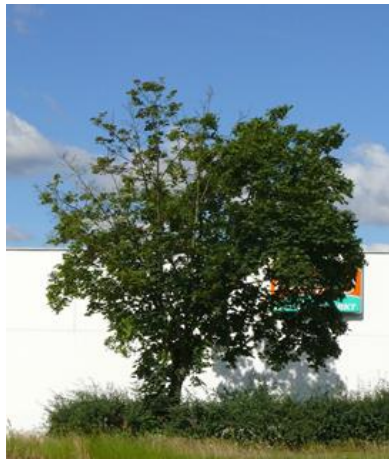
July 2016

effects. This is why – after the more dense foliage at the crown edge has receded – it is easier for the RF radiation to cross over to the other side of the crown. As a result of the increasing RF exposure level, the crown then also starts to lose leaves in this opposite area and thus the tree's inherent attenuation also decreases. In this way, the damage area spreads from the inside to the outside of the side of the crown edge facing away from the RF transmitter.

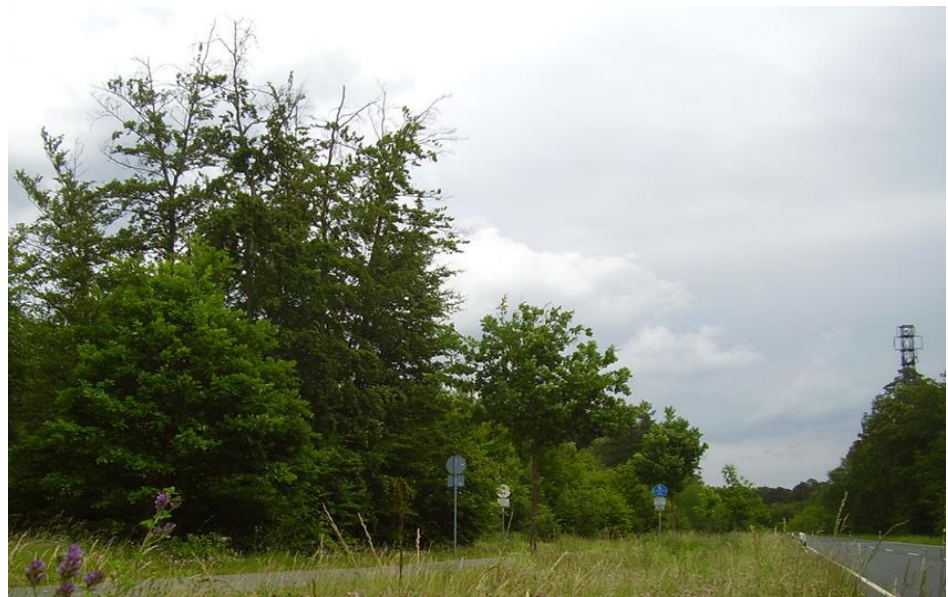
*Beech trees,  
June 2009*

*If the RF radiation exposure comes from above, the damage is particularly prominent at the top of the tree.*

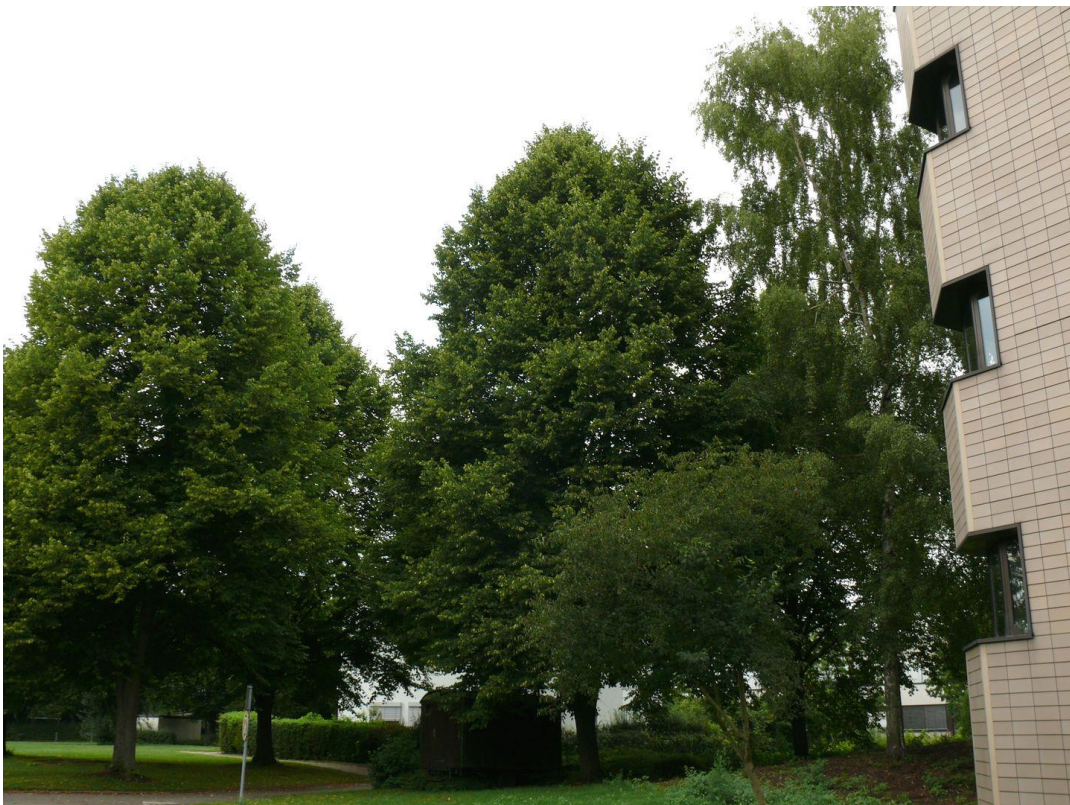
*July 2008*

*Tree crowns in a strip of greenery become damaged through the exposure to radiofrequency radiation*
